62 -68 LOW PETERGATE YORK

A Report on a Programme of Historic Building Recording

by George Geddes
and Isabel Mason

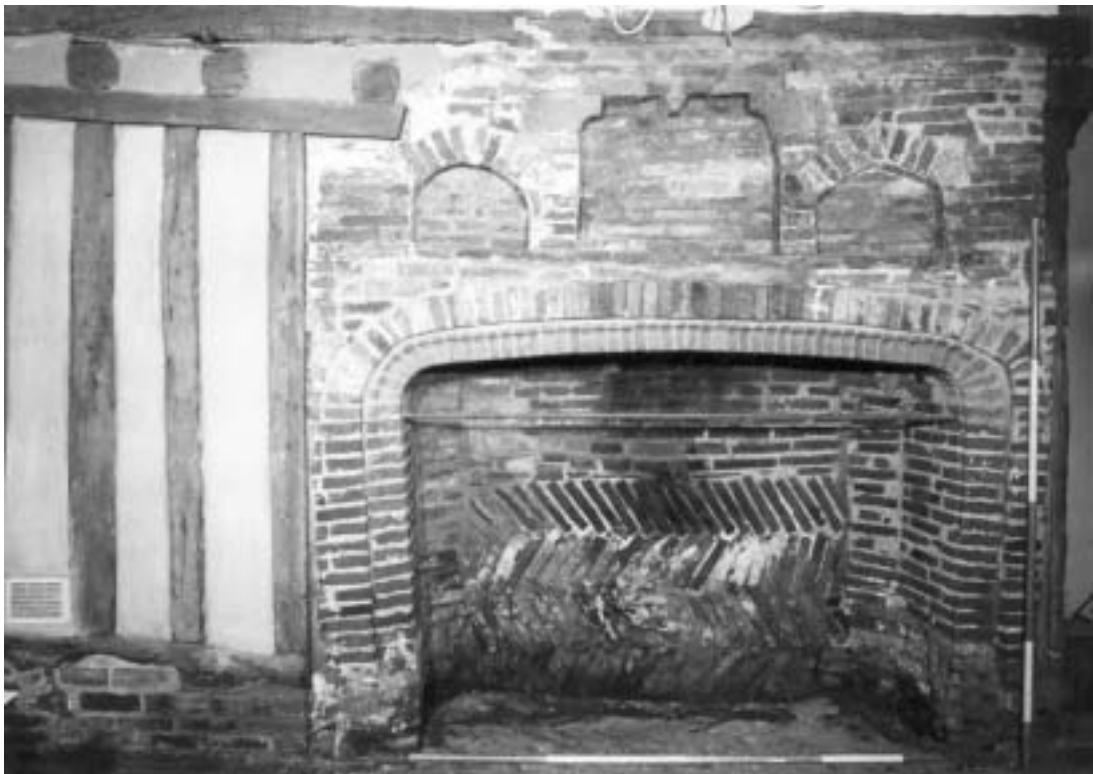
Plate 1

The internal room on the ground floor is partly beneath modern ground level and is plastered on all sides apart from the SW where a large brick fireplace has been inserted. Timbers are exposed on both sides of this fireplace (Plate 1).

Fireplace and timber-framing on the ground floor of Building A

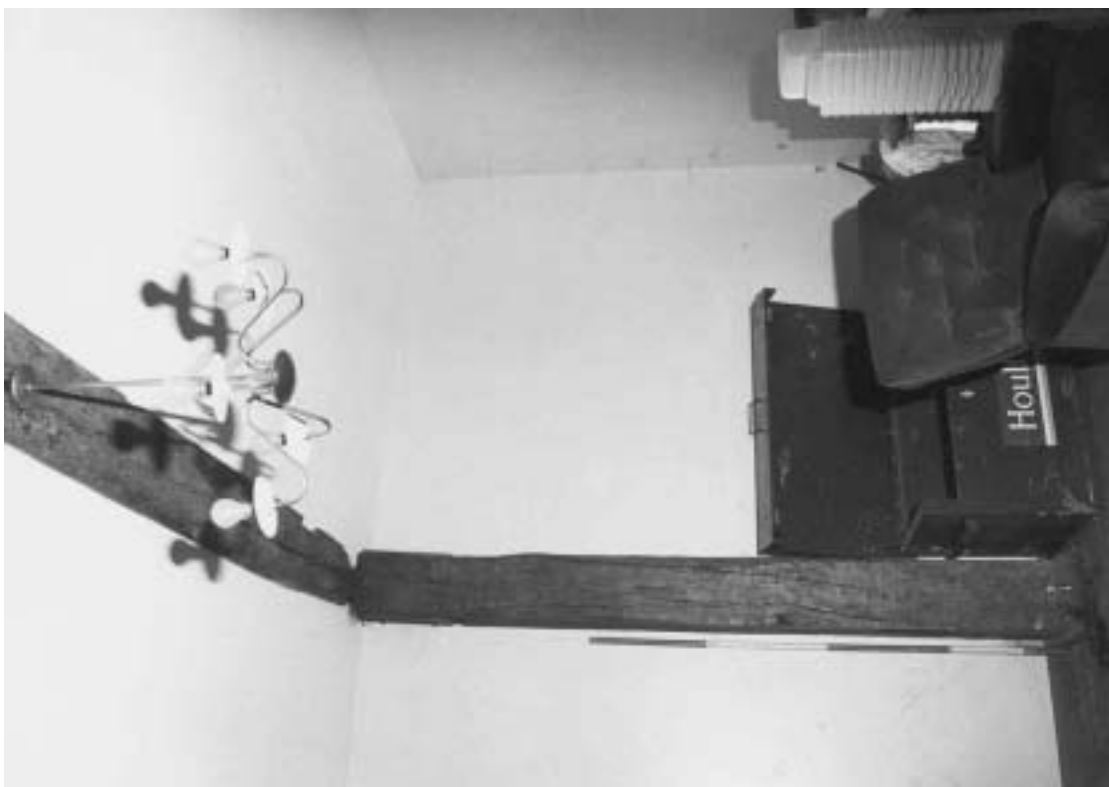
The SE and NW walls both contain a large projecting timber post that supports a large timber beam below the ceiling (Plates 2-3). On the first floor a similar arrangement of two projecting timber posts and a large timber beam at the ceiling exists. Otherwise the room is still plastered, apparently over concrete blocks. Access to this room is through the window since the staircase has been demolished. On the third storey, there are two small attic rooms, the larger in the uppermost extension of the building seen coming through the outshot roof in Elevation D and one in the rearmost gable. The former contains the reverse of the framing seen in the uppermost part of Elevations C and D and has two large purlins exposed (Plate 4). The rest of the room is covered with plaster. The smaller room to the rear has no distinguishing features though a hatch provides access to the roof space of this rearmost portion of Building A. The roof is a typical principal rafter roof with simple collars.

Plate 3
Principal post on the interior of the NW wall of Building A

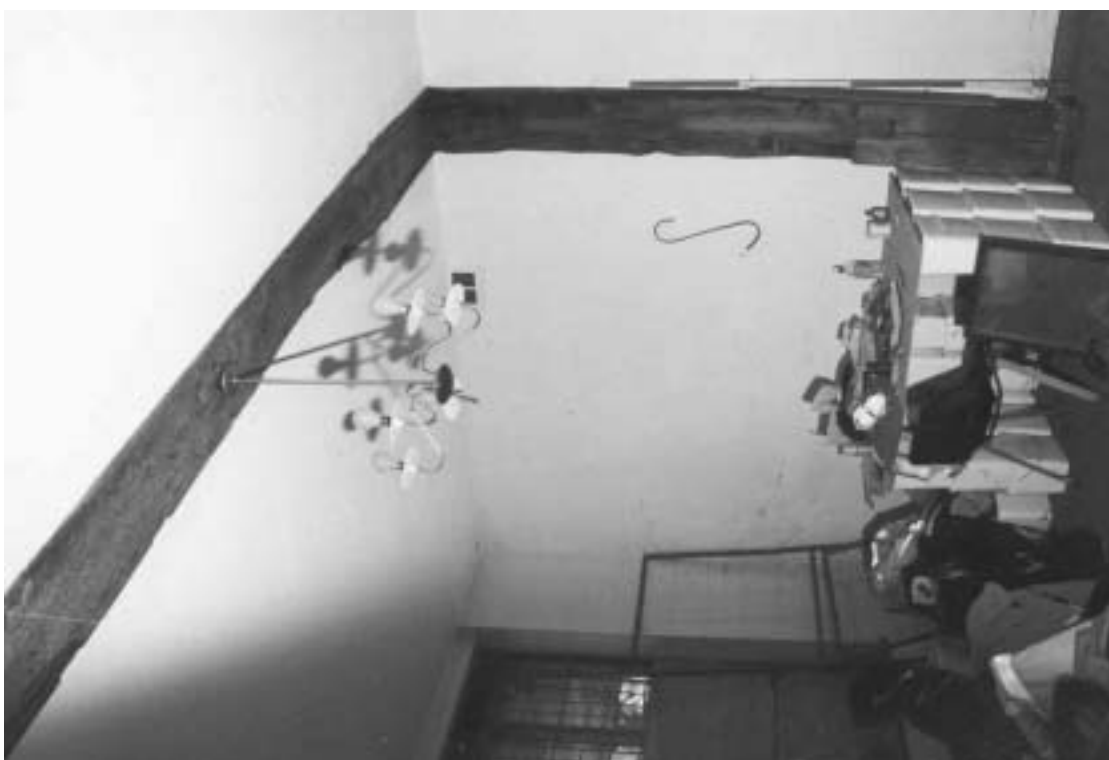
Plate 2
Principal post on the interior of the SE wall of Building A

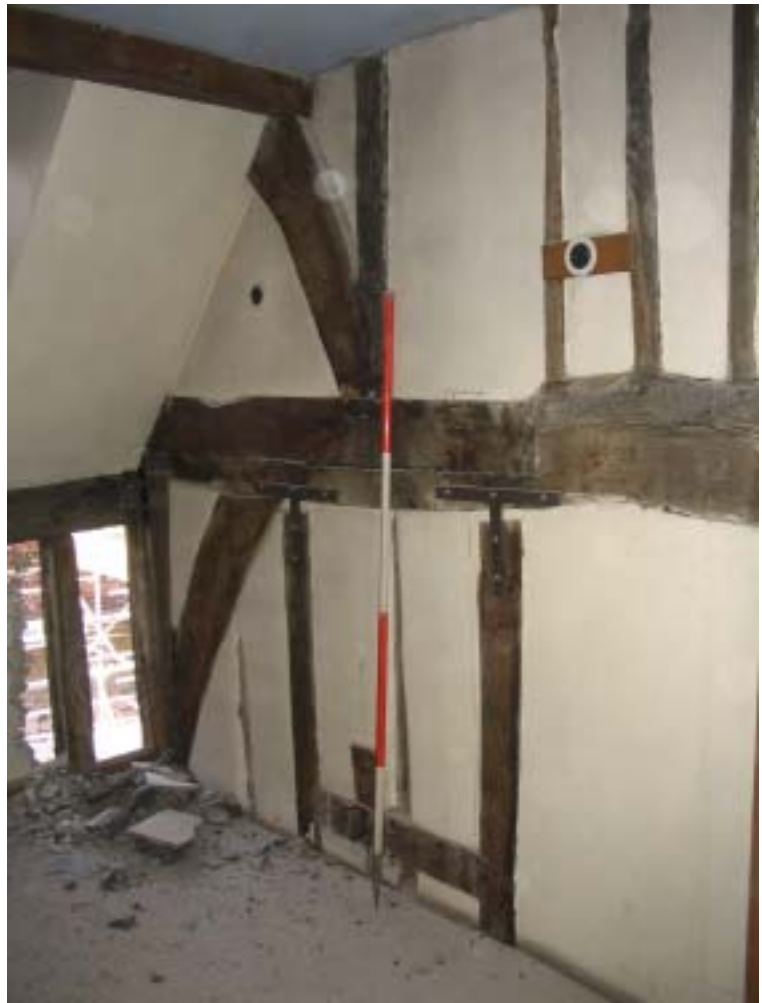
Plate 4

Timber-framing within the larger attic room of the uppermost extension of Building A

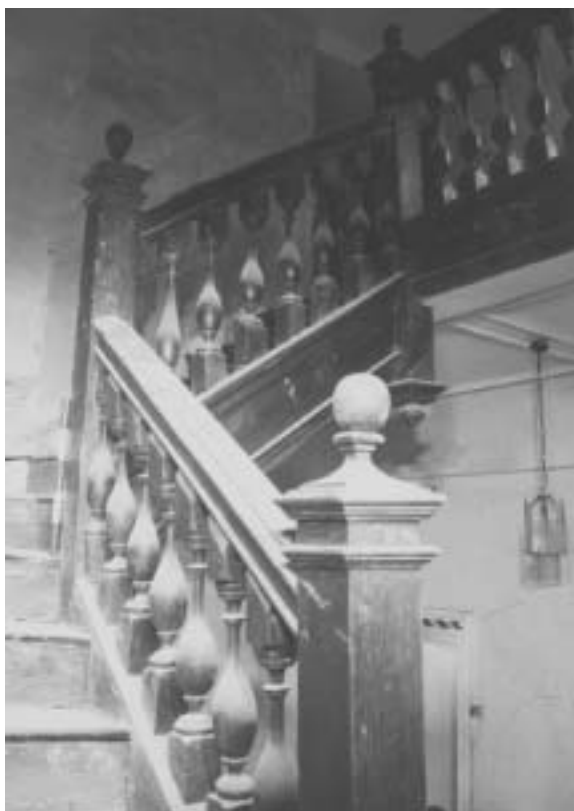
Plate 5
*The ‘Talbot Stairs’ from the ground
floor (Building B)*

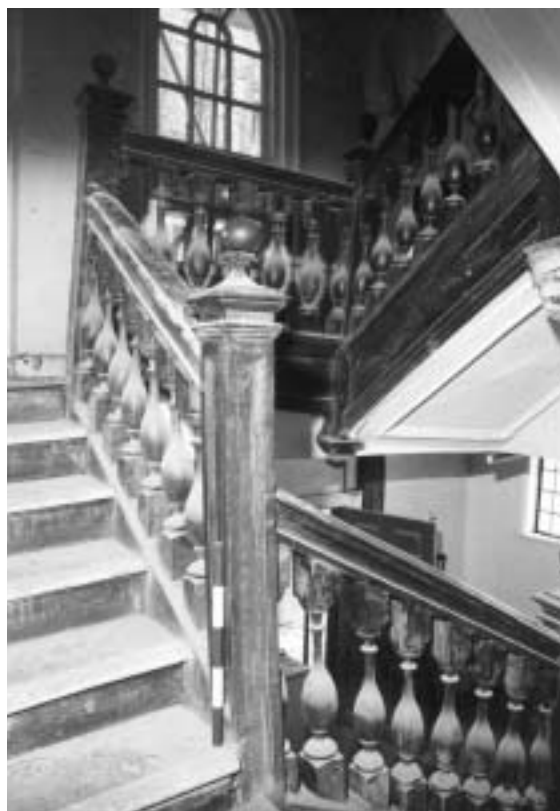
Plate 6
*The ‘Talbot Stairs’ from the first
landing (Building B)*

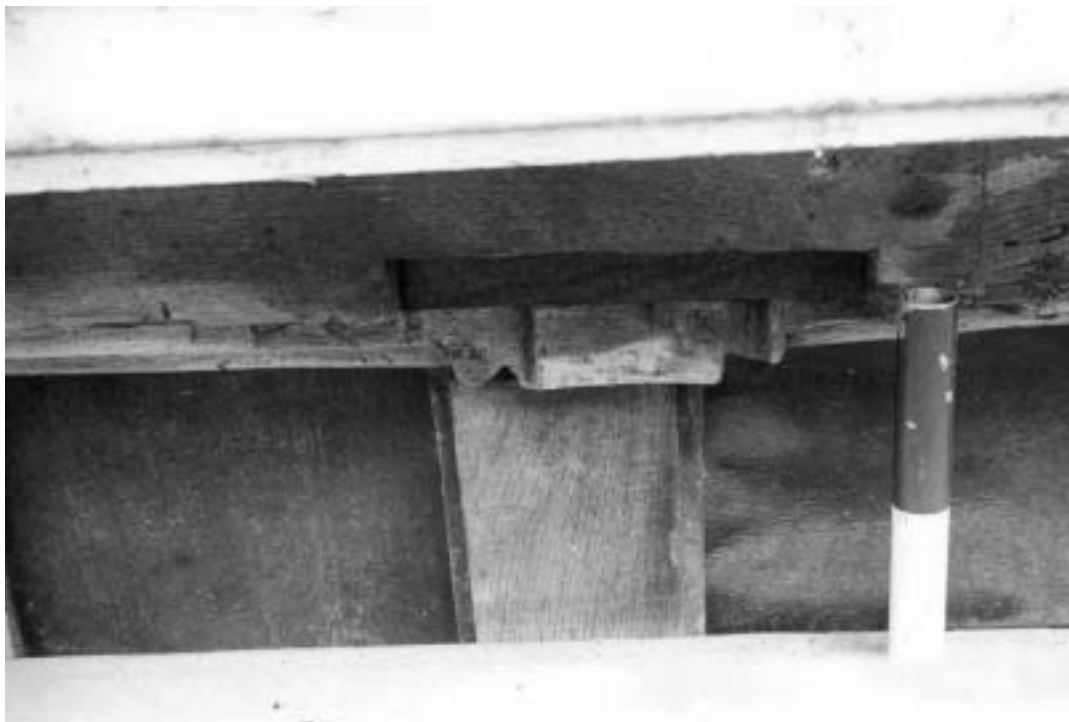
Plate 7

The wall plate of the lean-to is a moulded beam which supports a pantile roof with lead flashing that rises to intersect the main part of Elevation E (Plate 7).

Moulded beam below the roof of the lean-to Elevation E (Building B)

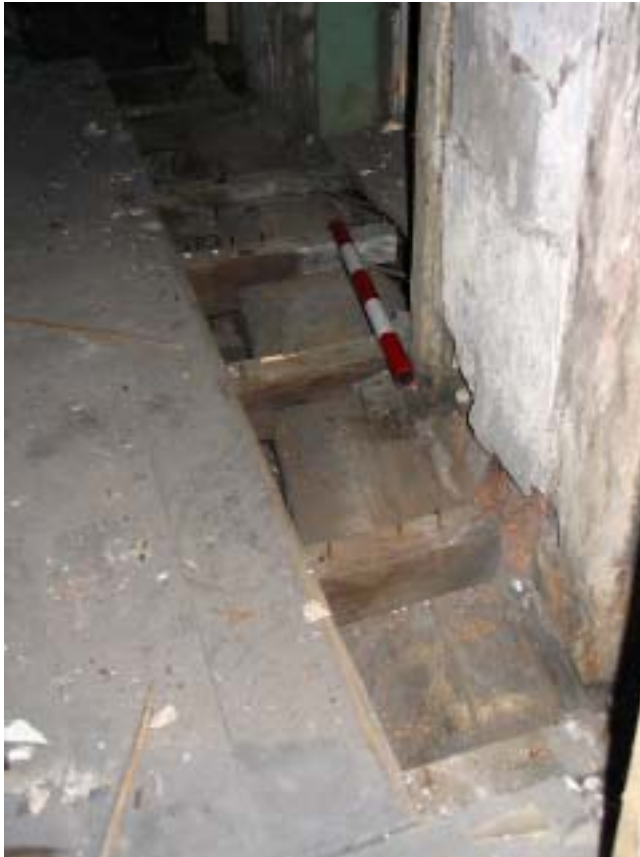
Plate 8

Large beam within the roof space of the lean-to (Building B)

The roof space of the lean-to has a ceiling that is supported on the inside by a large beam (Plate 8). This beam also supports the timber framing above, which is obscured by the lean-to roof, these studs are represented on the elevation drawing (Fig. 8) as dashed lines. This framing consists of eight studs with a small doorway providing access from the internal staircase (the 'Talbot Stairs') to the roof space of the lean-to. These studs have been infilled with concrete.

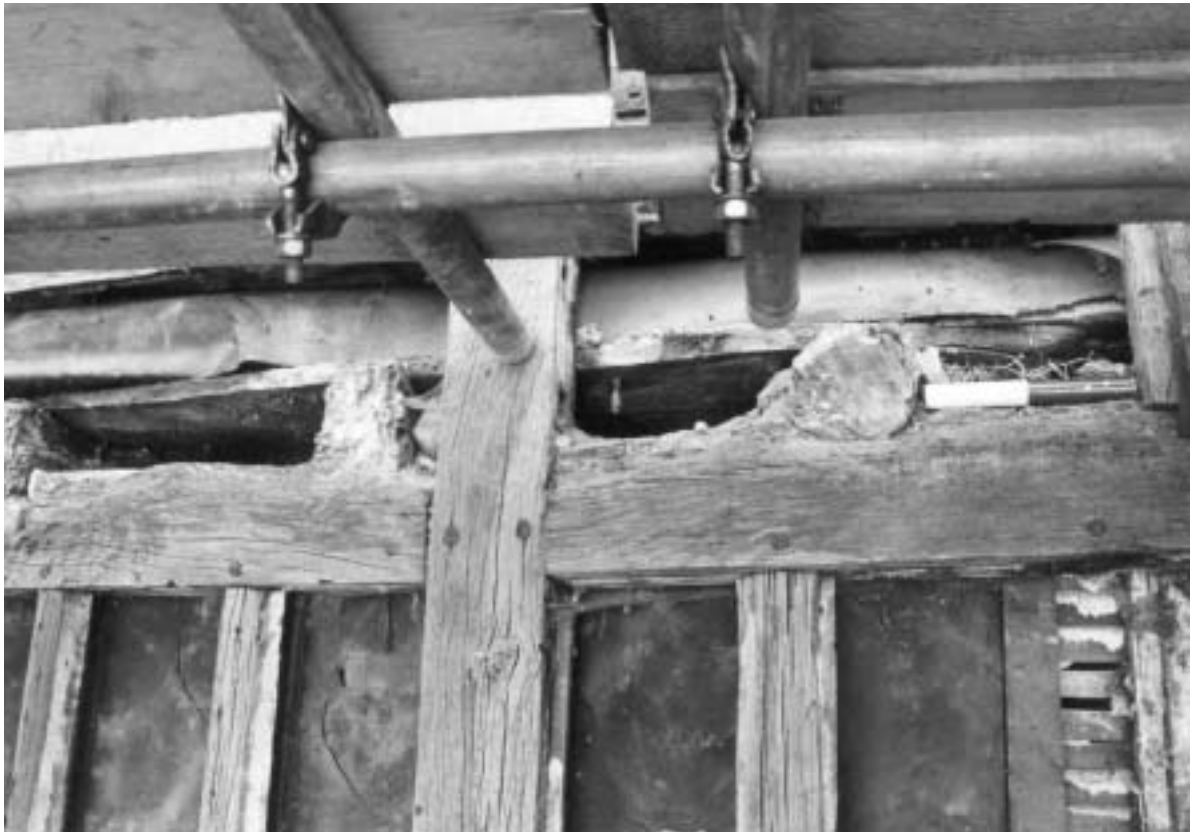
Plate 9

*Floor joists inserted between the window heads and the third storey girding beam
Elevation E (Building B)*

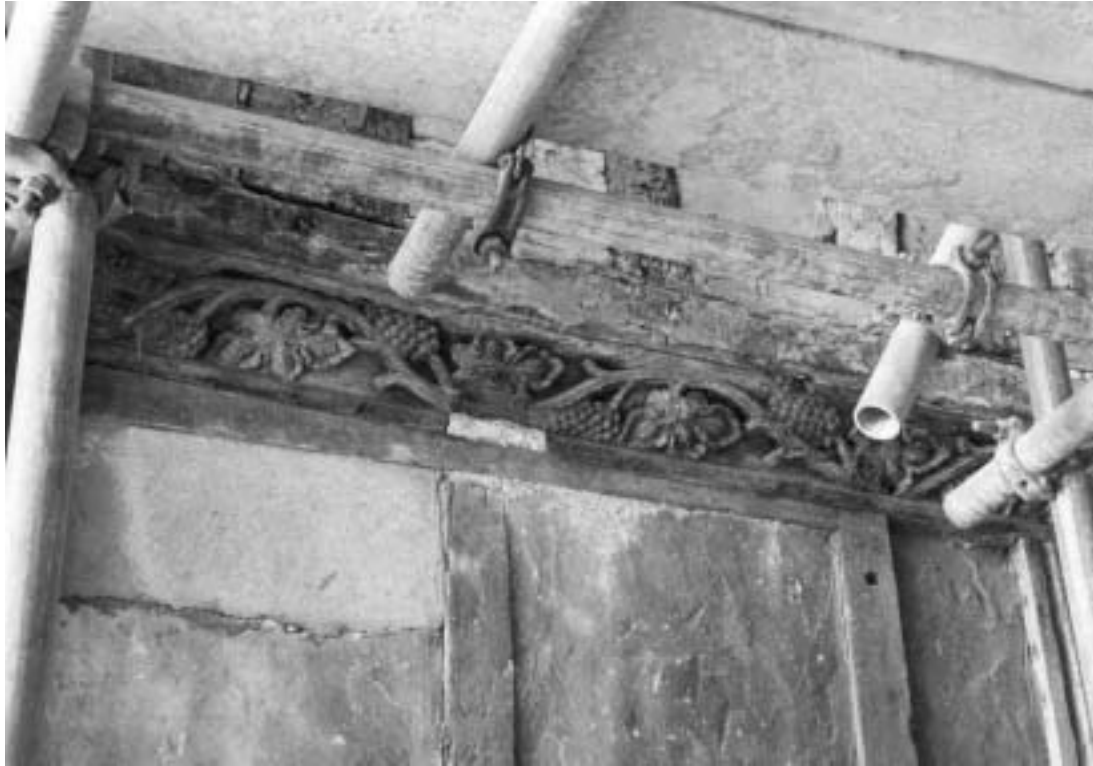
Above this frame is a beam which extends from the large post below the girding beam through the intersection with Elevation G1 and ends in the ceiling area of Building D. This beam is carved on its lower part with a vine scroll (Plate 10).

Plate 10
Carved beam above the door of Elevation F (Building B)

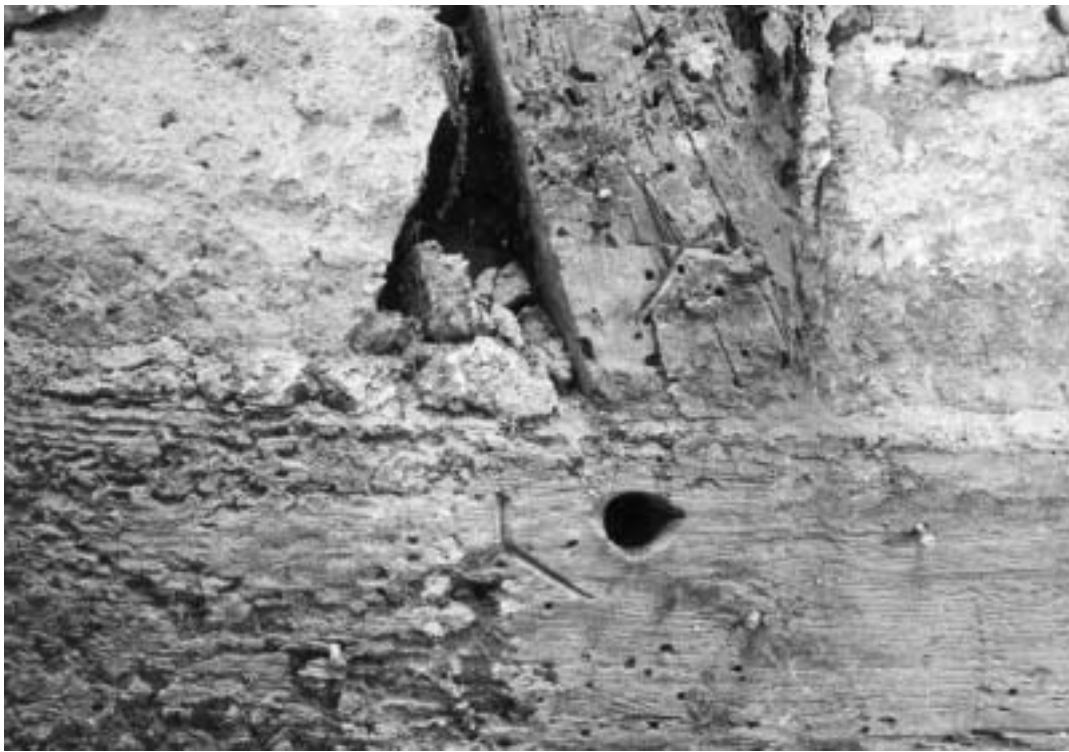
Plate 11

Carpenter's marks on second floor beam of Elevation F (Building B)

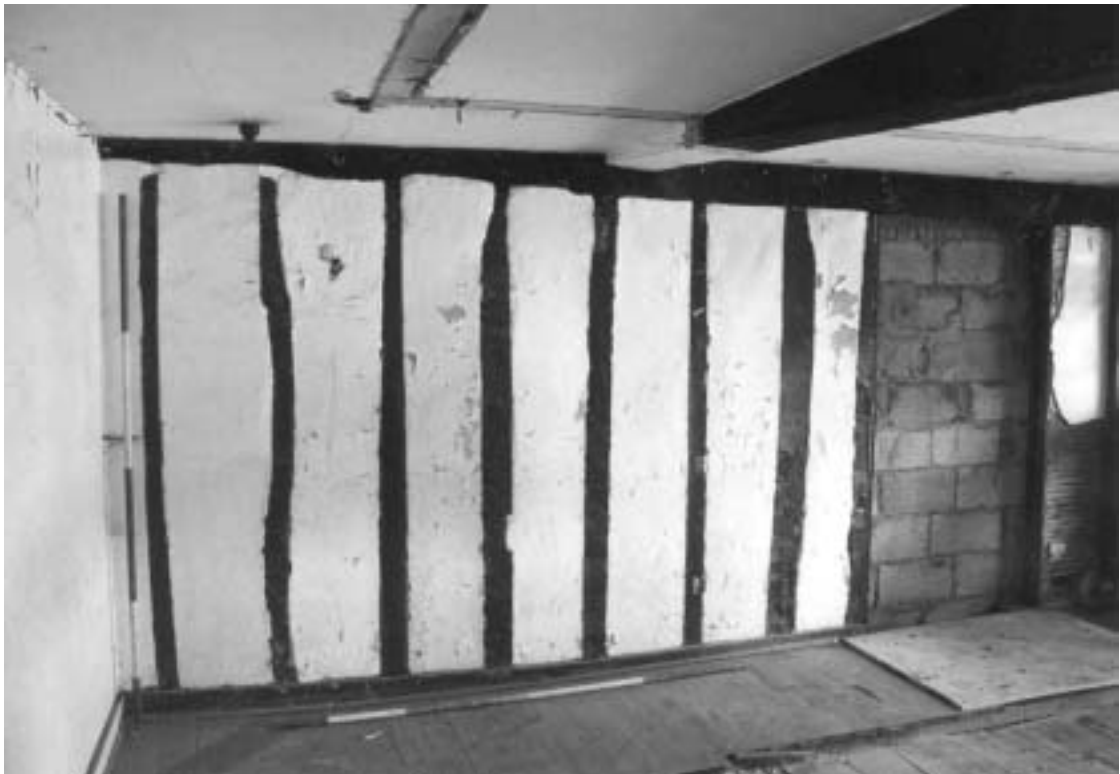
Plate 12
Timber-framing on the internal NW wall of the first floor of Building C

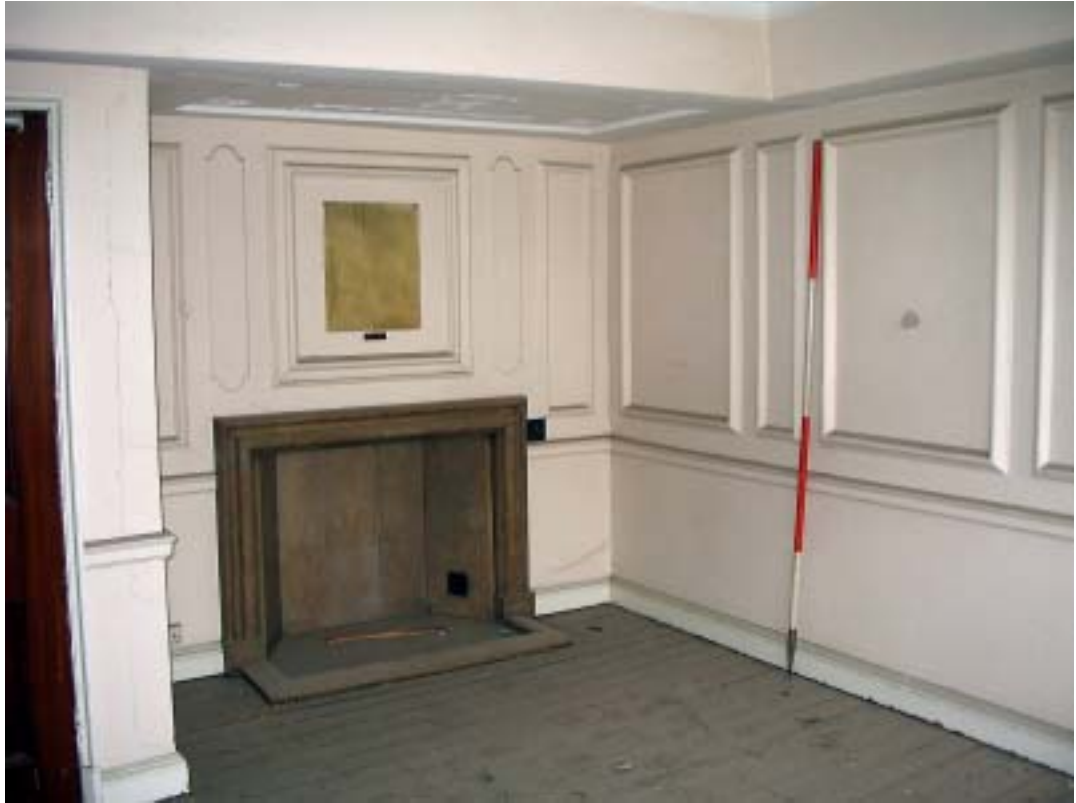
Plate 13
Panelled room on the second floor Building C

On the second floor is a room with panelled walls and ceiling (Plate 13). It contains a large marble fireplace with the socket for an electric fire. The bay window has a small window seat on its interior. Above the fireplace the plaster ceiling is decorated with the keys of St Peter's, an inscription which reads '*NON NOBIS SOLUM*' and a date of 1928, surrounded by two roses, a thistle and a daffodil (Plate 14). The ceiling above the fireplace, and to a lesser extent all around the room, is stepped in to cover the substantial beams which support the roof. The roof structure is accessed from the small stair mentioned above and is of a simple truss construction with single collars, supporting the pantile roof.

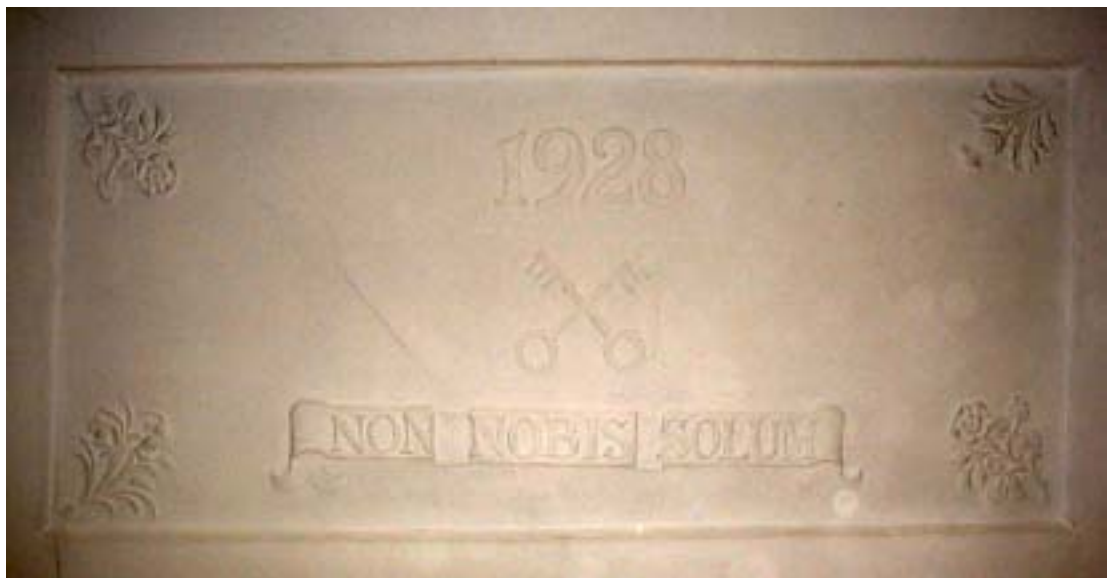
Plate 14
Decorated plaster ceiling above fireplace of the second floor room of Building C

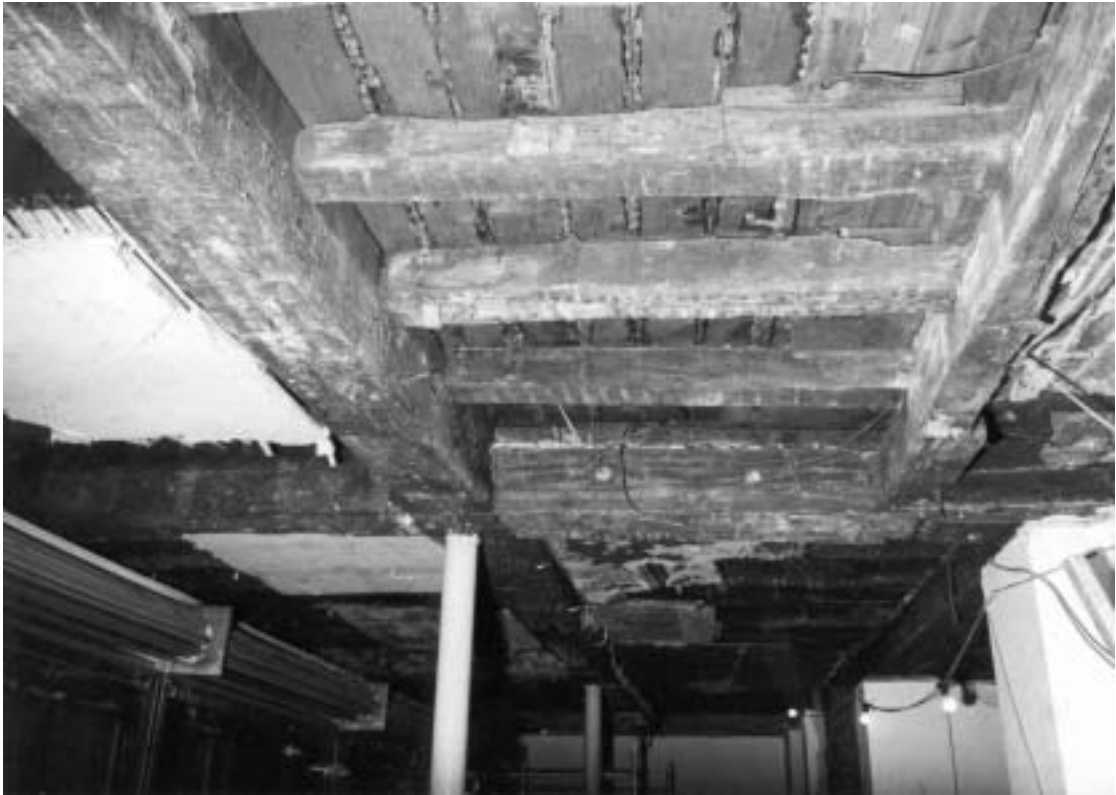
The walls of the ground floor shop contain little detail and are plastered throughout, however the ceiling is composed of the remnants of a massive timber-framed floor. This included four principal beams running perpendicular to the street and measuring 0.34m by 0.30m. Three bridging beams are double tenoned into these 3m from the street front forming a coffered effect. The floor joists are mostly edge set and tenoned into the bridging beams (Plate 15).

Plate 15
Ceiling on the ground floor of Building D

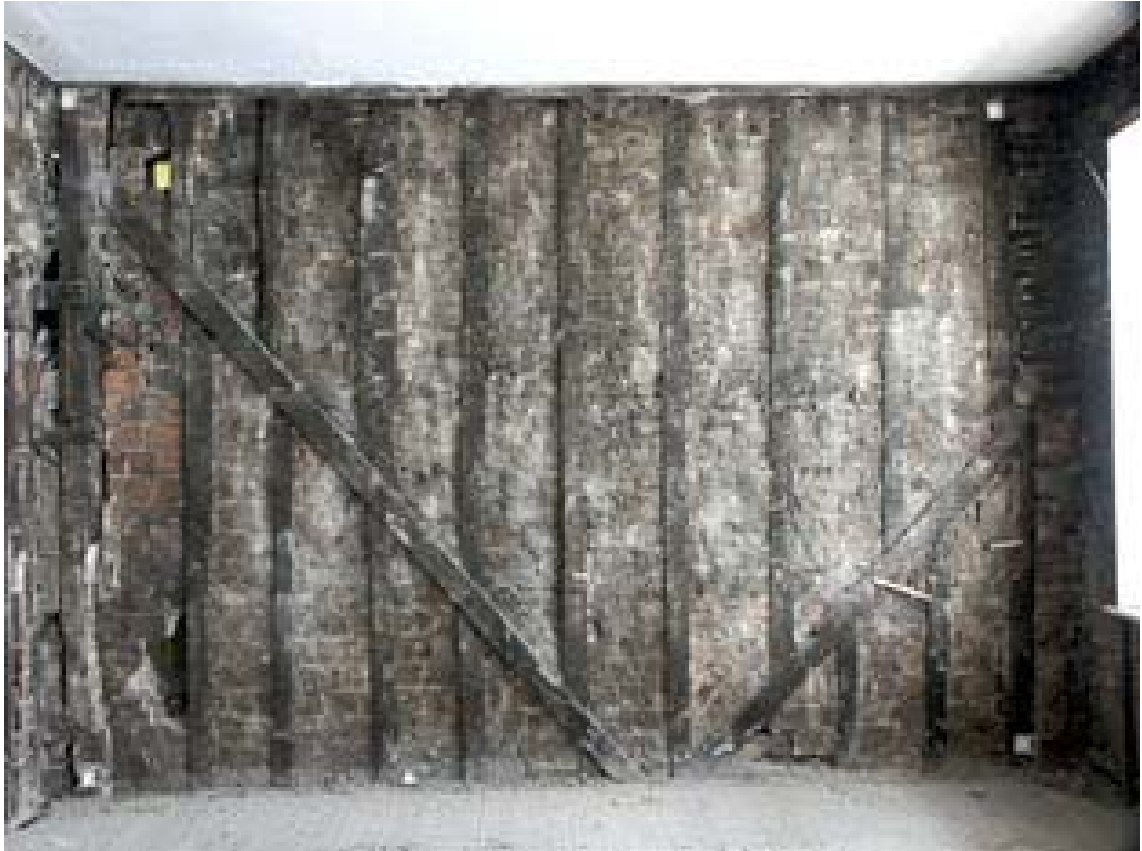
The lath and plaster has been removed from the first floor room at the SE end of Building D. On the SE wall these revealed a timber frame of two posts, nine studs and two upward straight braces filled with brick. On the NE wall of the room the chimney block is constructed of brick incorporating part of the surrounding timber frame which is very irregular and partly filled with brick. A small niche to the right is now empty and the doorway accesses the Talbot stairs of Building B. The opposite side wall between the two first floor rooms is composed of an irregular frame of studs, rails and braces covered on both sides by lath and plaster (Plates 16 and 17).

Plate 16
Internal SE wall of the SE room in Building D

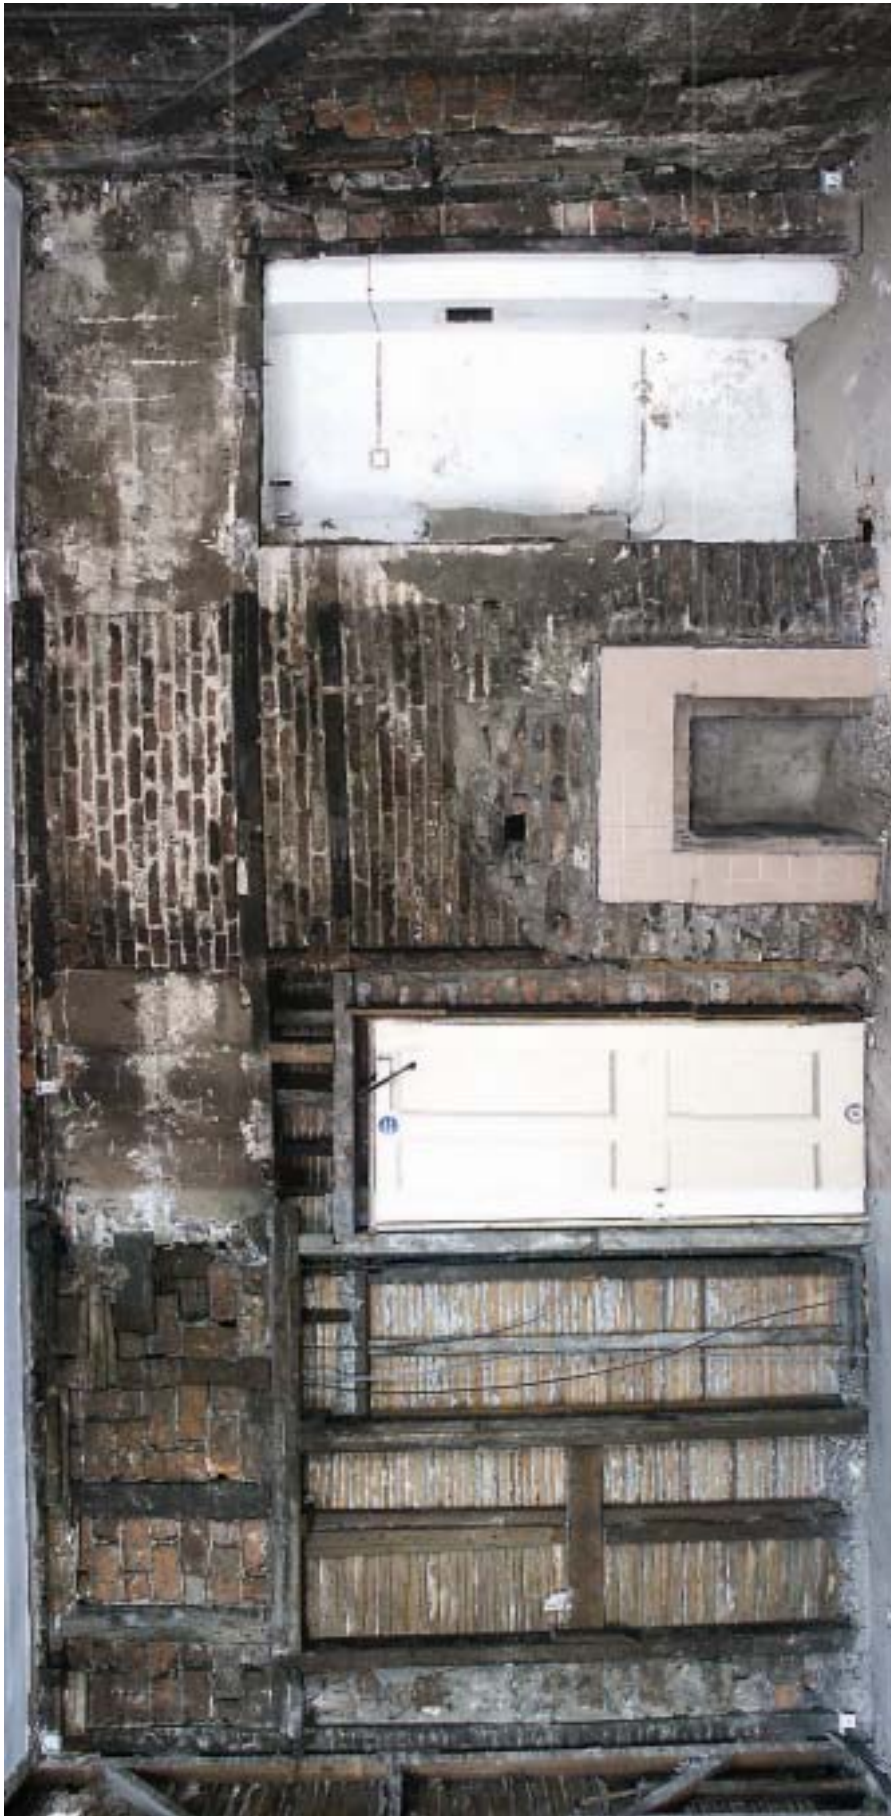
Plate 17
Internal NE wall of the SE room in Building D

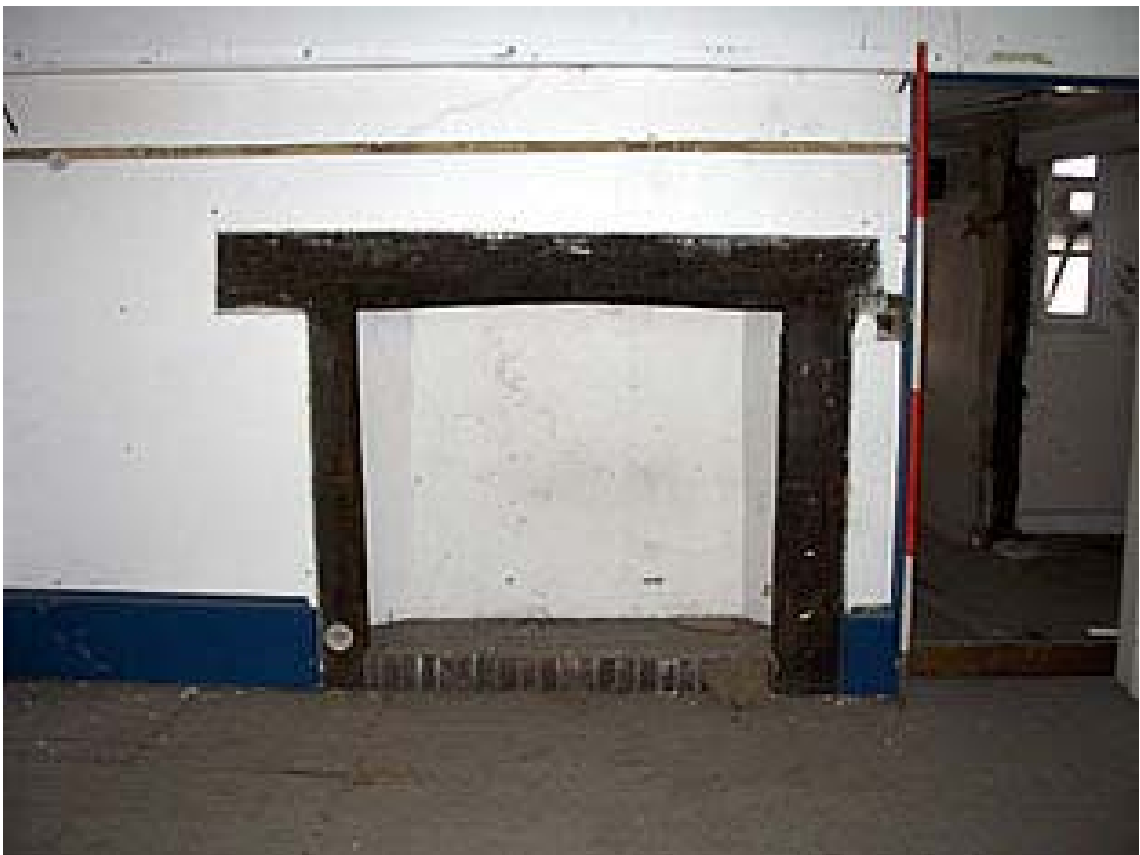
The walls of the adjacent room were not exposed but the large timber fireplace is constructed of two reused posts and a lintel with a herringbone brick plinth (Plate 18). This room is accessed via a passage in G1 from the Talbot stairs and previously also from No. 62 via Building C. The rooms above these are of the same dimensions and retain their plaster. Each has a fireplace in its back wall. A small staircase behind the NW room provides access to the attic. This is lit by two dormers and divided by a thin timber partition.

Plate 18
Fireplace in the NE wall of NW room in Building D

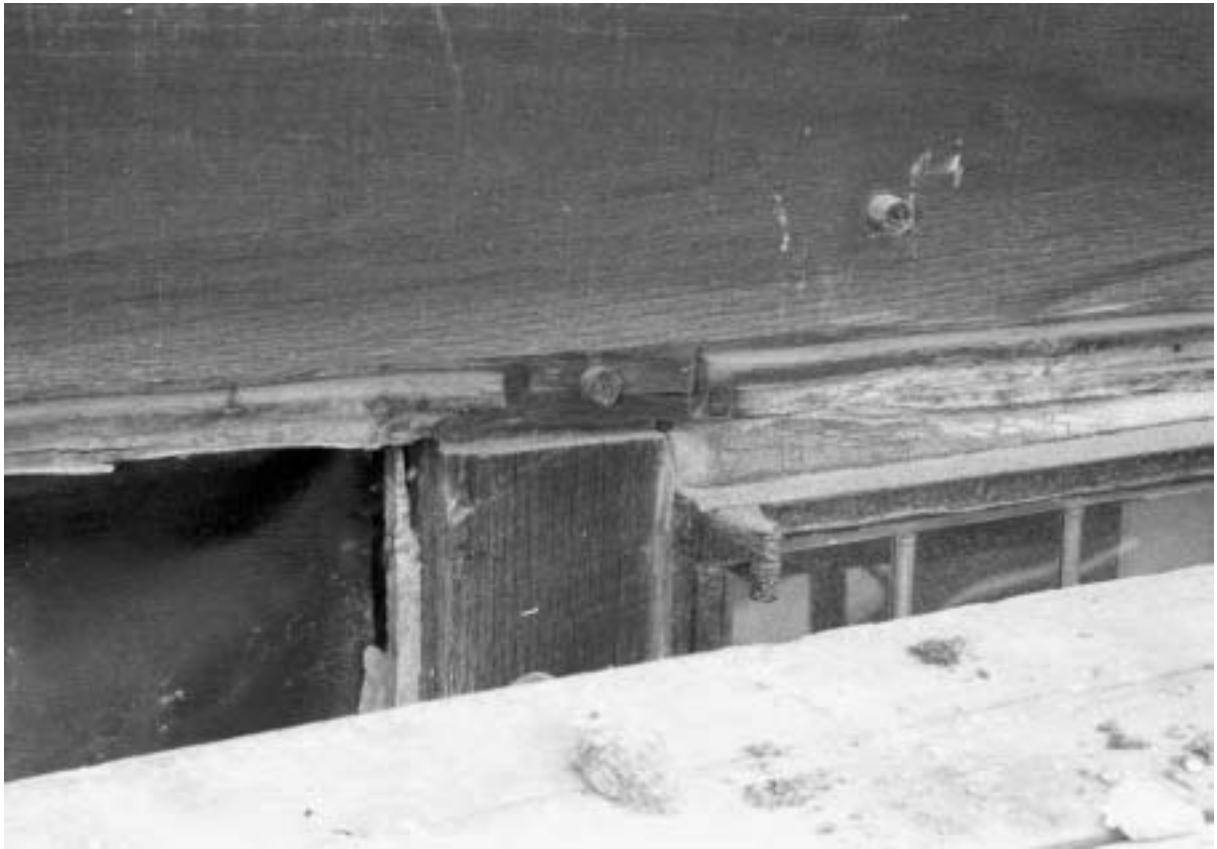
Floor boards and some joists are visible in this level as the infill has been removed. A girding beam above this supports three studs and is jointed to the continued right hand post. There are two eighteen light windows with small fixed leaded panes set in the studs and above is a moulded beam with a cover board over the wall plate (Plate 19).

Plate 19
Moulded beam beneath the wall-plate of Building D (Elevation G1)
